Chippewa Creek

Watershed Management Study

**CHIPPEWA CREEK
WATERSHED MANAGEMENT STUDY
FINAL REPORT**

December 1996

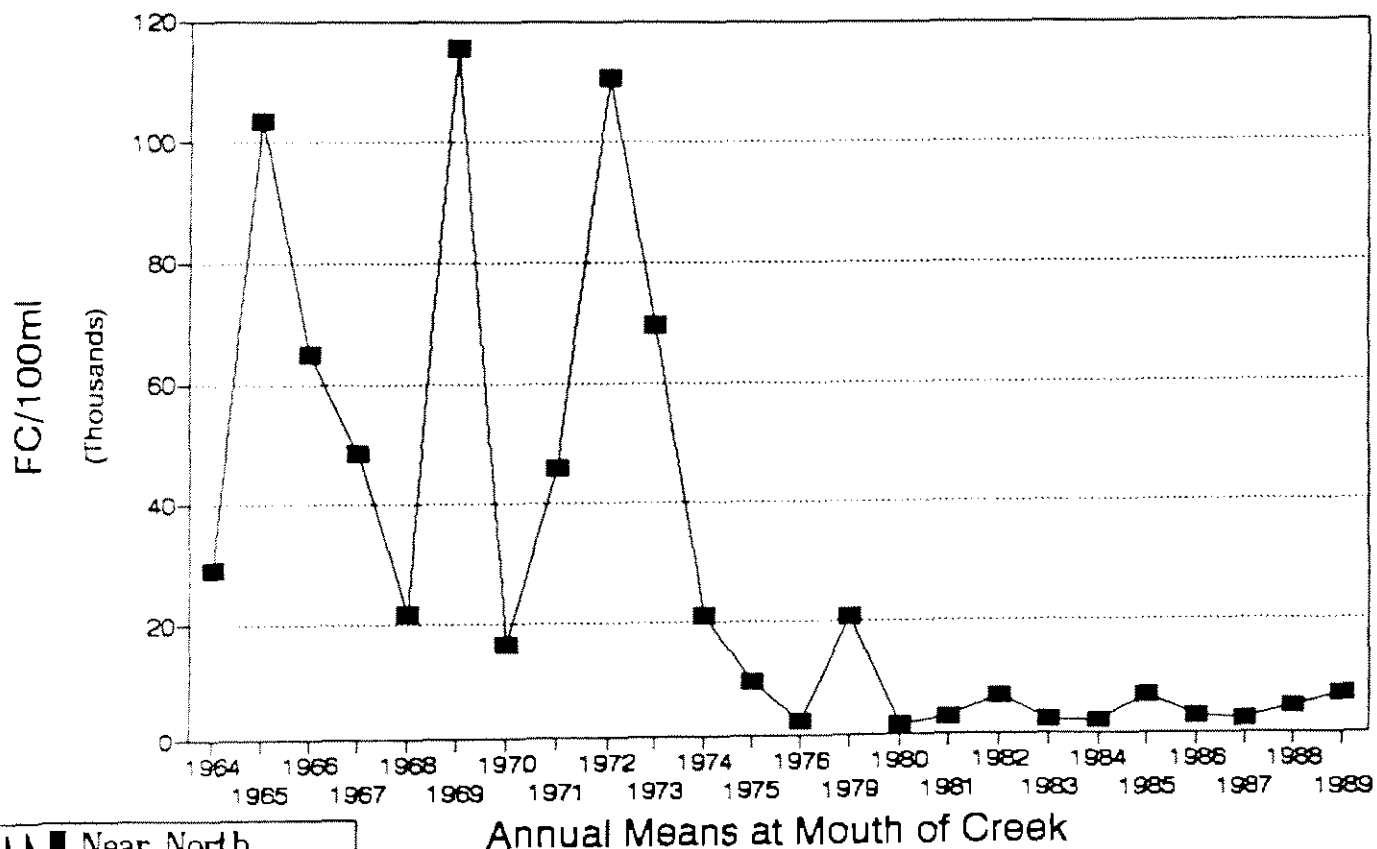
Figure 2.4.11

Chippewa Creek Management Study Fecal Coliforms

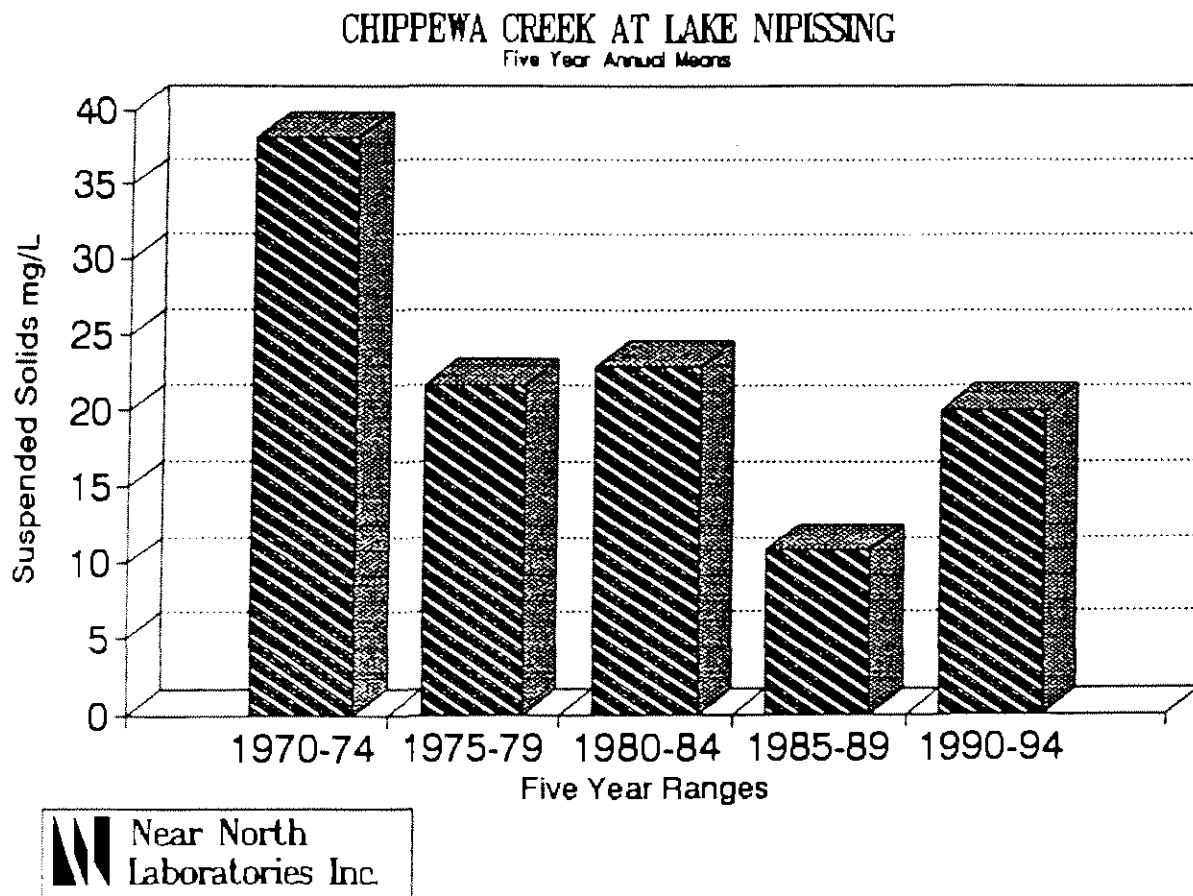
Figure 2.4.12

been determined. Since the seventies, levels have continued to decrease slowly (with exception of the late 1980s). Appendix E provides detailed water quality information on sampling sites, historical data, dry flow and rain event graphs and responses to Steering/Public Committee questions.

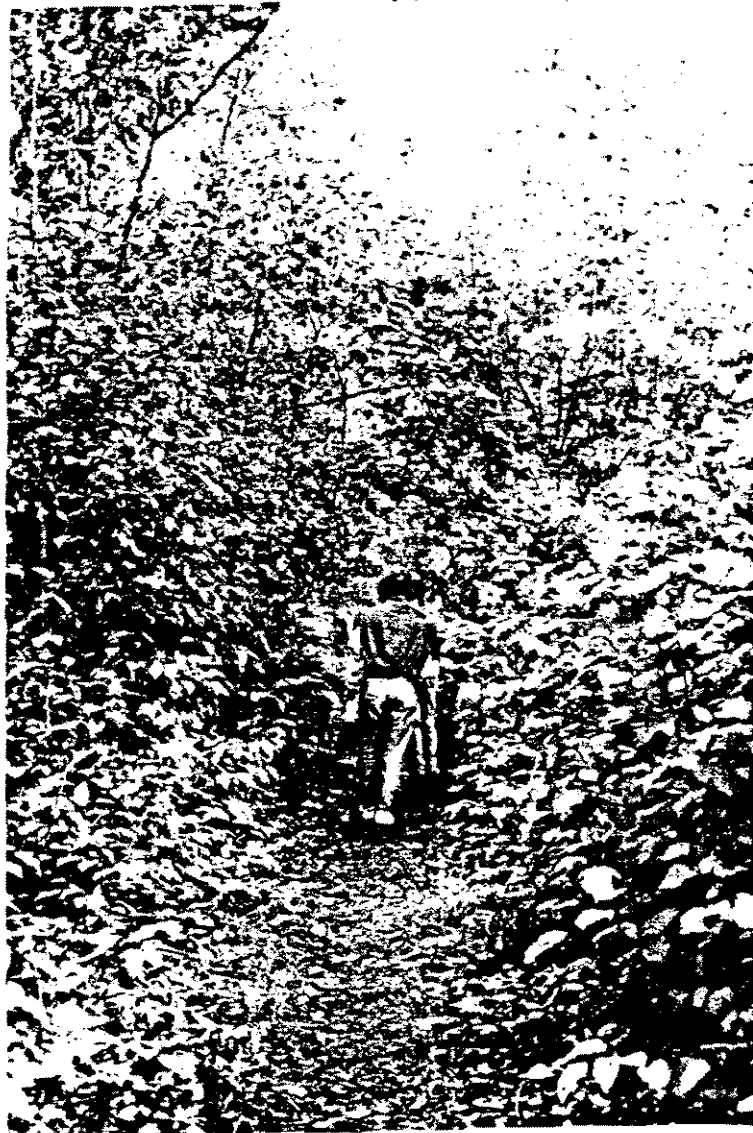
Figure 2.6-2

Photograph of Old Portage or Winter Trail Remnant from Trout Lake to Chippewa Creek

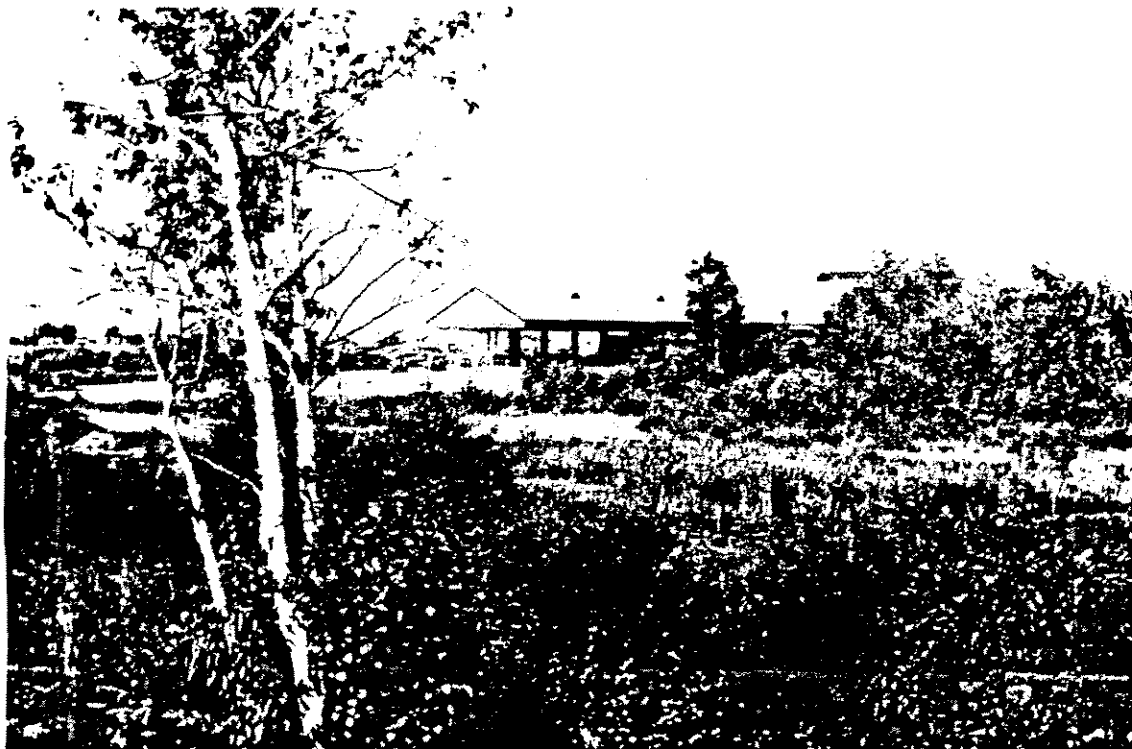
Figure 2.6-4

Prehistoric Archaeological Site (Portage Landing) West End of Delaney (Mud) Lake

This site (Figure 3) is located at the extreme west end of Delaney Lake. It is situated on a flat rock outcrop that forms a small point. This location (Figure 4) would be ideal for landing birchbark canoes at a portage trail that went west along the creek which connected to Chippewa Creek in what is now Thompson Park.

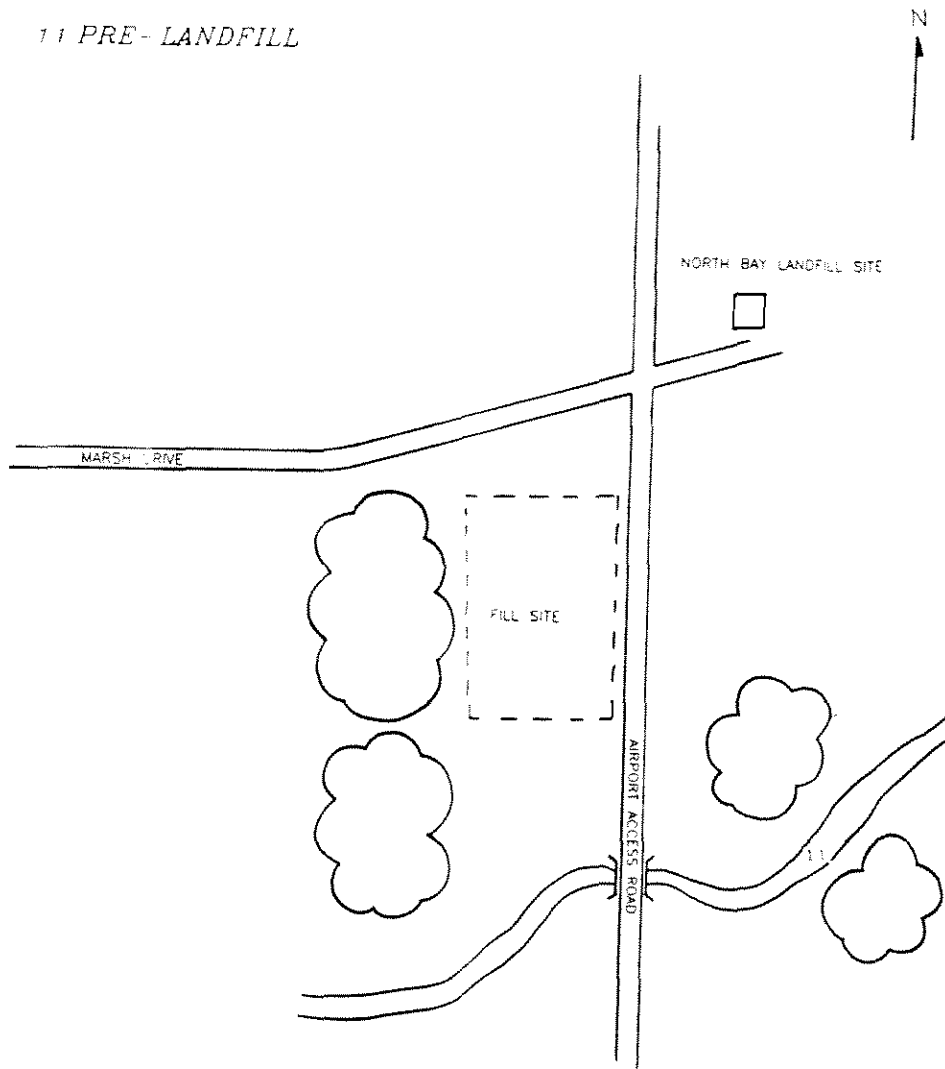
11 PRE-LANDFILL

Immediately east of the landfill is the Pre-Landfill sampling site (Site #11). This site was chosen for comparison with the landfill tributary sampling site. An important consideration with respect to this site is that it consists of glaciofluvial sands and gravel and bedrock (Gartner Lee, 1993) which is representative of the landfill's geological base. This sampling site also represents the northeast arm of the Chippewa Creek watershed.
